**US Army Corps
of Engineers®**
Engineer Research and
Development Center

Deformable Bullnose Energy Absorbing System (BEAS)

Report 2: Head-On Impact with a Deformable BEAS and Introducing a Collapsible Arch

July 2011

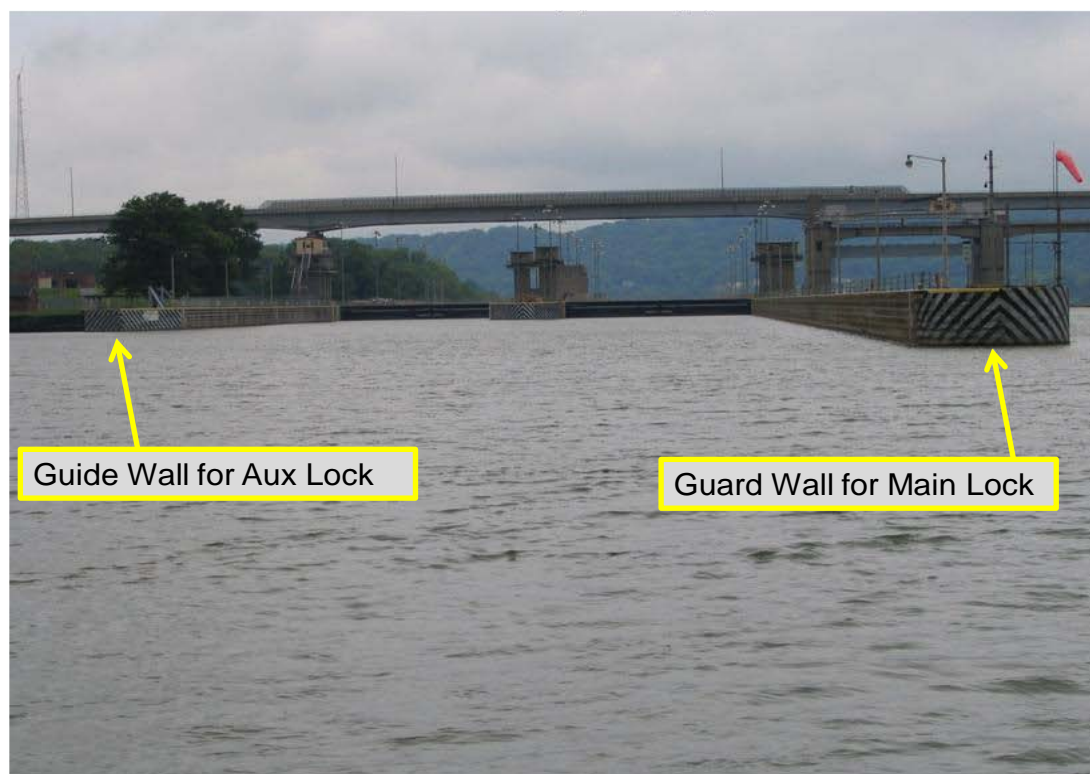
Figure 2.1. Markland Locks.

Kentucky bank side and drive toward the locks staying close to this bank. Once the head of the tow is fairly deep into the approach, sometimes almost to the nose of the landside guide wall for the auxiliary lock (see Figure 2.1), the tow slides across to the guard wall for entrance into the main lock. For low flow conditions, the tows come in closer to the guard wall, as shown in Figure 2.2. The head of this tow landed on the guard wall about 650 ft upstream from main lock. Project personnel described another approach where the outdraft catches the tow causing it to be more riverward than desired. In this case, the pilot steers the head toward the bank and has even grounded the barges on the bank. An item to note for the Deformable BEAS design is that the Markland project receives the most drift and debris of the navigation projects in Louisville District.

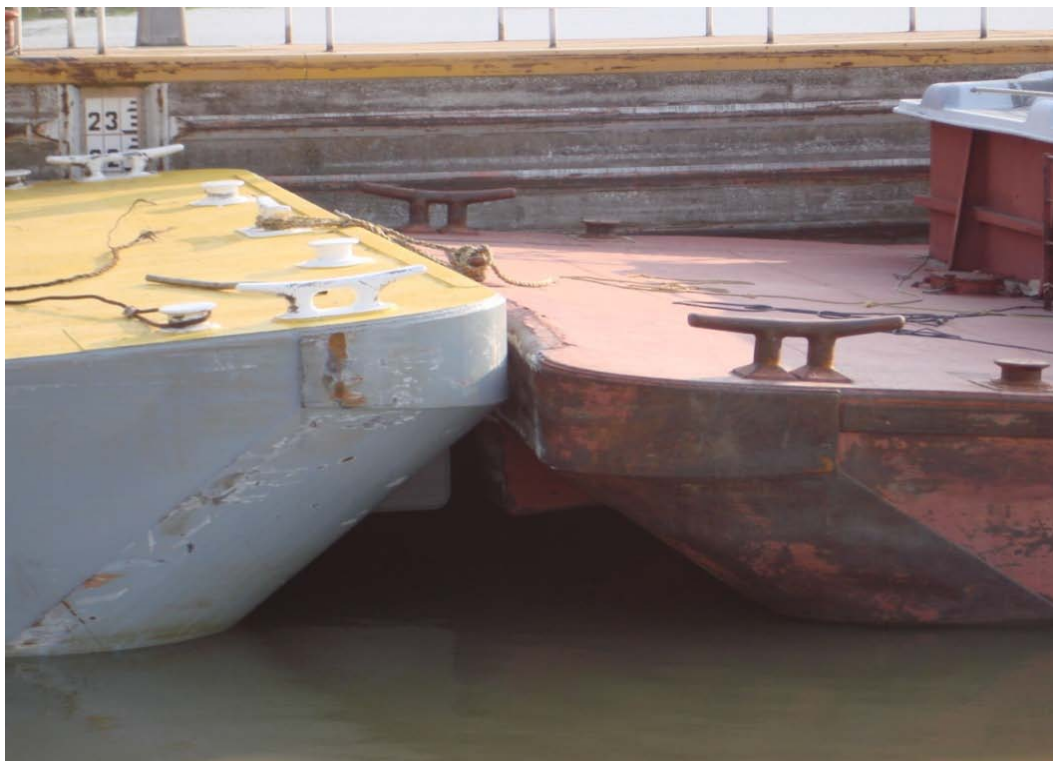
Figure 2.20. View of damage to barges that hit the guide wall at Newt Graham Lock and Dam 18.

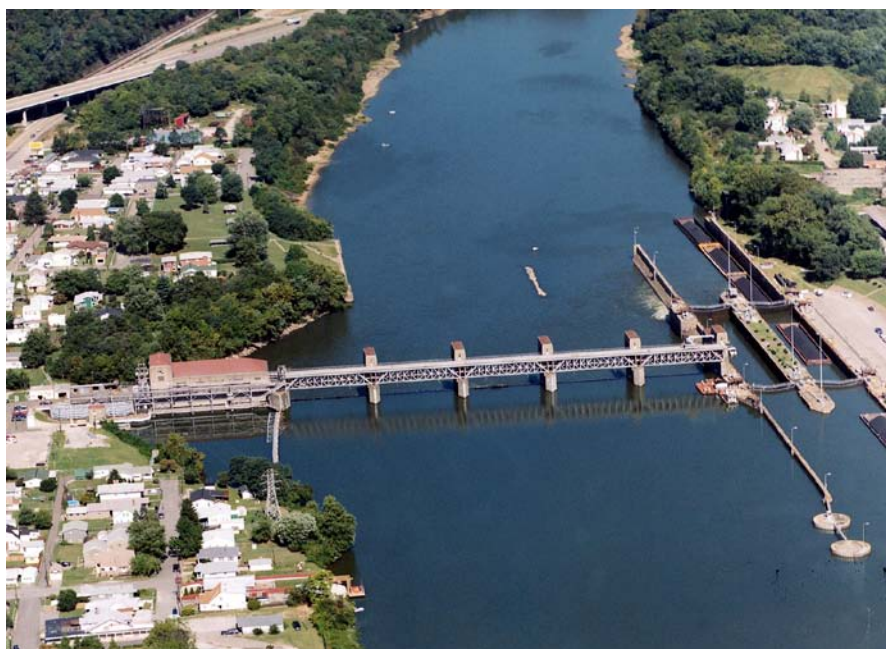
Figure 5.17 Marmet Lock and Dam with Cellular Bullnose
